# STOUGHTON, WISCONSIN

August 18, 2005

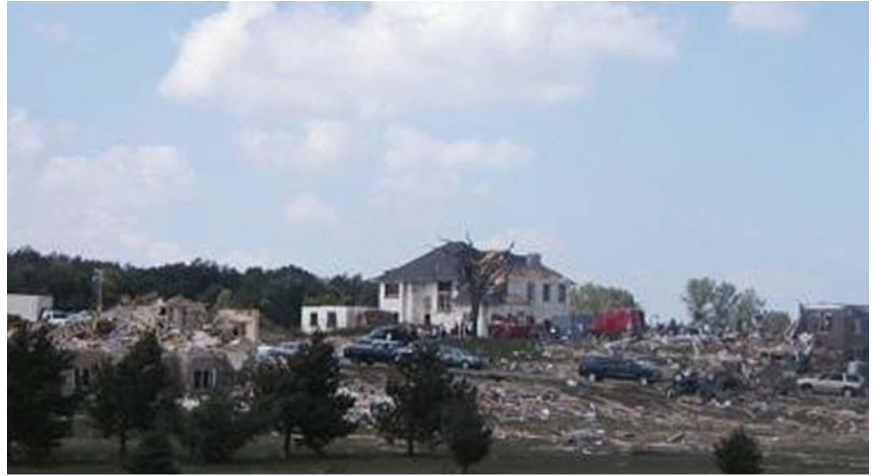
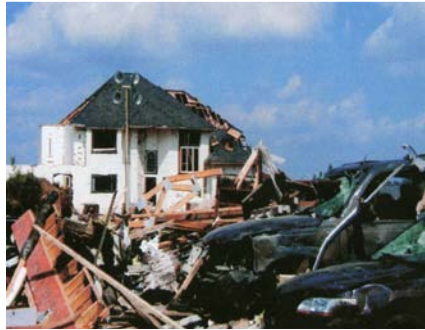
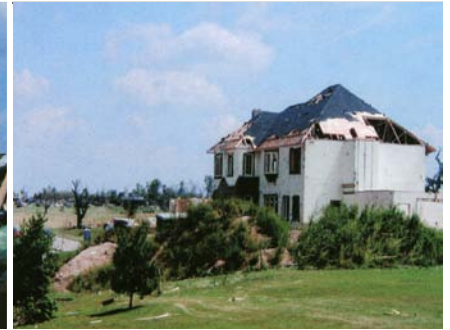
One structure – still under construction but built with ICF walls – was still standing after a F-3 class tornado tore through Greenbriar Estates in Stoughton. The home was under roof, with windows installed and brick cladding begun.

Engineering analysis showed the ICF walls were not damaged and had not moved. Construction was resumed on the 3-story, almost 5,000 square foot home as soon as debris had been cleared away. Debris from the storm was found 75 miles east of Stoughton (flying debris is the primary cause of injuries and fatalities during tornados and storms).
