STOUGHTON, WISCONSIN

August 18, 2005

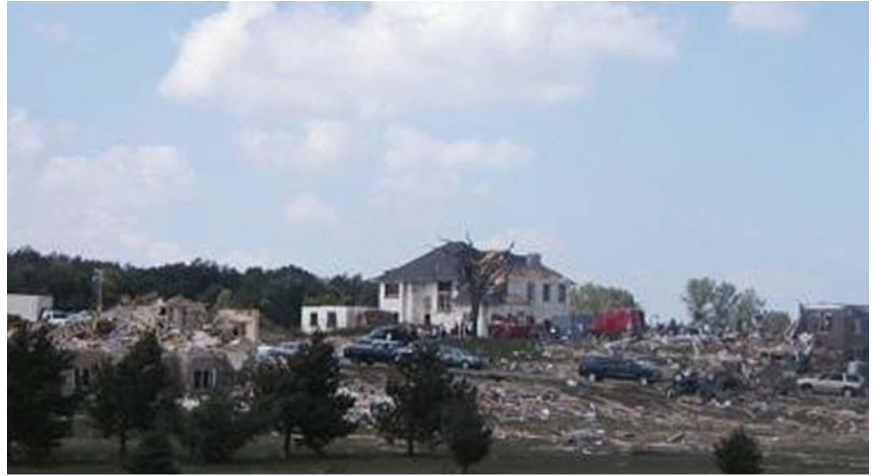
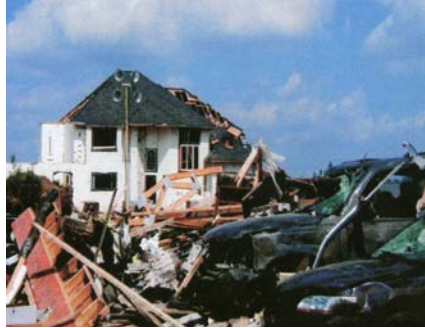
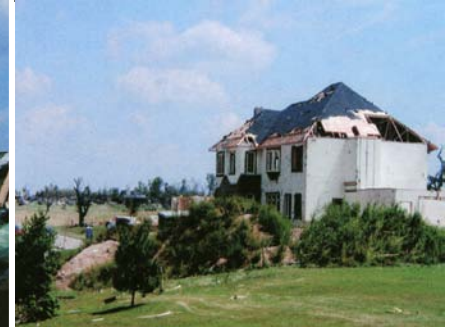
One home – still under construction but built with ICF walls – was still standing after a F-3 class tornado tore through Greenbriar Estates in Stoughton. The structure was under roof, with windows installed and brick cladding begun.

Engineering analysis showed the ICF walls were not damaged and had not moved. Construction was resumed on the 3-story home as soon as debris had been cleared from the development. Debris from the storm was found 75 miles east of Stoughton (flying debris is the primary cause of injuries and fatalities during tornados and storms).
